# YOUR CASTLE HOME INSPECTIONS INC.

## INTERNACHI RESIDENTIAL

1234 Main St. Clearwater FL 33763

02/24/2022 9:00AM

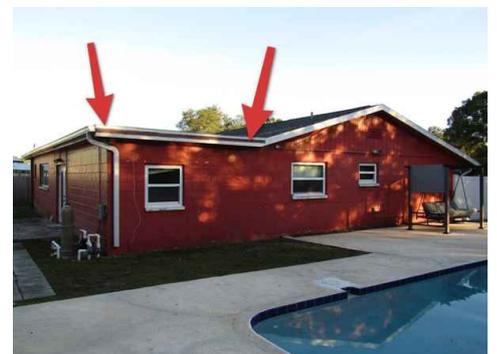
#### 2.2.1 Roof Drainage Systems

##### **GUTTERS MISSING**

There is a section of gutter that is missing on the side of the structure that the pool is on. Gutters are recommended as they collect rainwater from the roof and direct it away from the building.

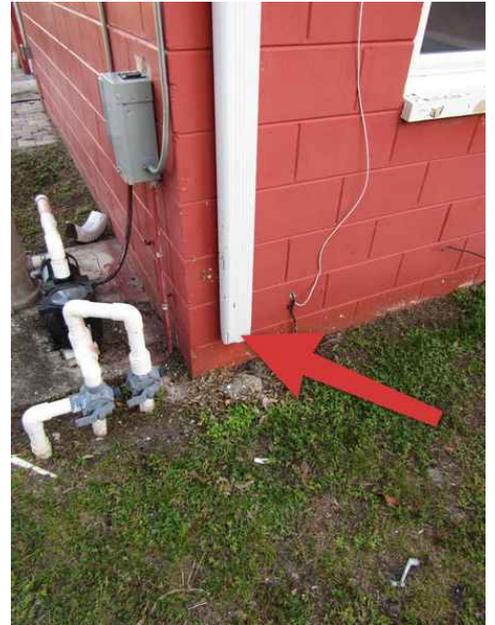
#### 2.2.2 Roof Drainage Systems

##### **DOWNSPOUTS DRAIN NEAR HOUSE**

One or more downspouts drain too close to the home's foundation. This can result in excessive moisture in the soil at the foundation, which can lead to foundation/structural movement. Recommend a qualified contractor adjust downspout extensions to drain at least 6 feet from the foundation.

[Here is a helpful DIY link](#) and video on draining water flow away from your house.

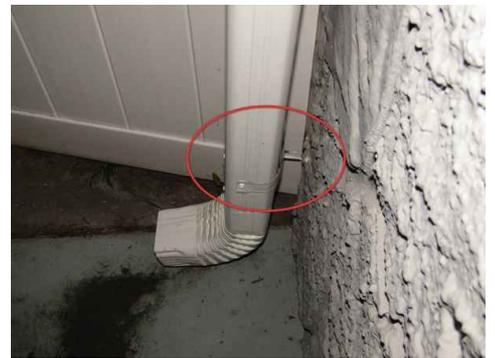
front of house

#### **DOWNSPOUT DETACHED FROM HOUSE**

Contact a qualified professional.

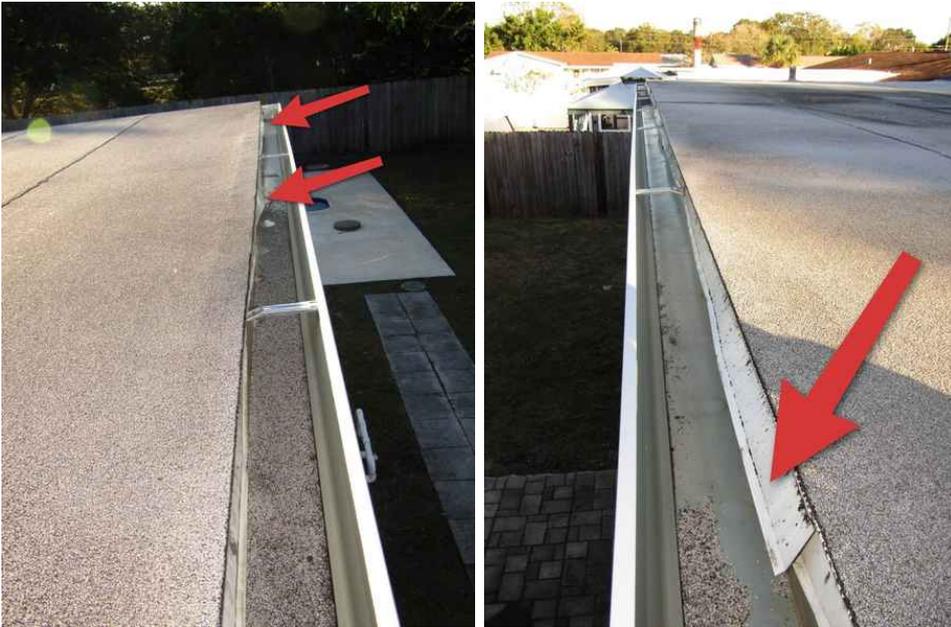
### 2.3.1 Flashings

#### **LOOSE/SEPARATED**

The drip edge along the back of the house was observed to be loose or separated, which can lead to water intrusion. Recommend a qualified roofing contractor repair.

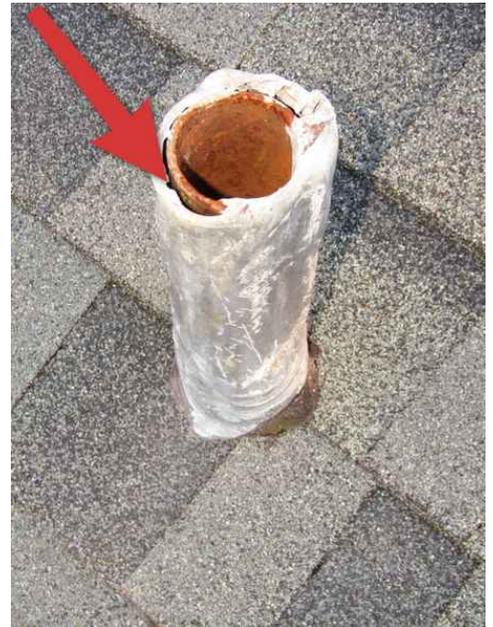
2.4.1 Skylights, Chimneys & Other Roof Penetrations

**VENT STACK(S)**

The lead boot around the vent stack needs to be replaced to keep water from entering between the pipe and the sleeve

Contact a qualified professional.

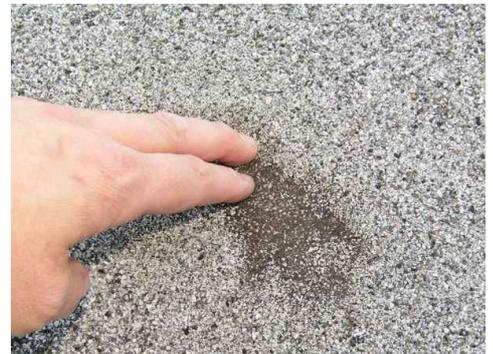
2.5.1 Secondary Roofing

**PONDING**

Observed evidence of ponding in one or more areas of roof. Ponding can lead to accelerated erosion and deterioration. Recommend a qualified roofing contractor evaluate and repair.

The picture is showing a think layer of loose granules that have been washing off the roof and gathering here in one spot because the water ponds here.

Contact a qualified professional.

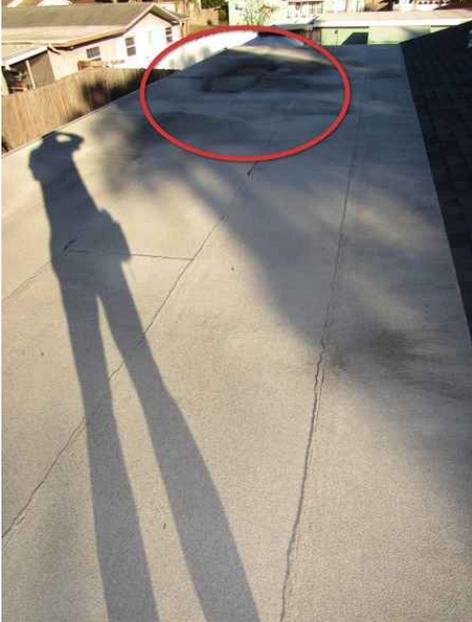
## 2.5.2 Secondary Roofing

**ROLL ROOFING CONDITION**

The flat roof on the rear of the structure is not properly sealed. The seams are able to be lifted which will allow water to penetrate through and cause damage. Recommend a licensed roofer evaluate and make the necessary corrections

signs of ponding

Contact a qualified professional.

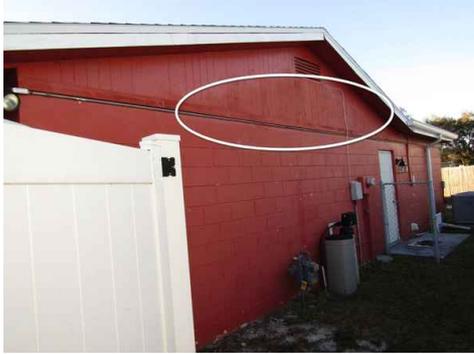
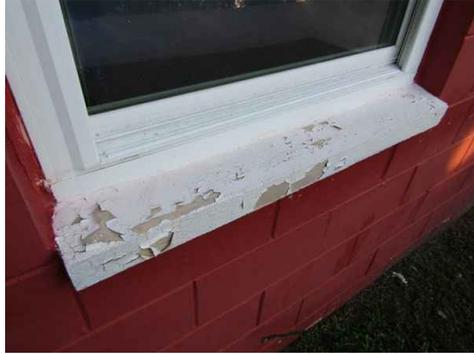
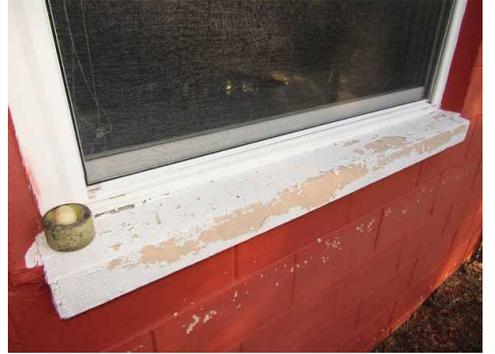
3.1.2 Siding, Flashing & Trim

The paint has been peeling on the window sills. Areas of loose paint should be properly prepped prior to painting

scrape and repaint

Contact a qualified professional.

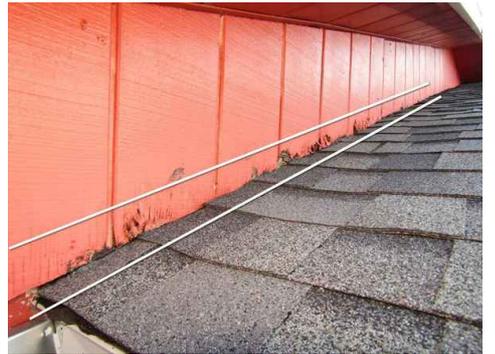
3.1.3 Siding, Flashing & Trim

There is not proper clearance between the siding and the roof of the garage. Because of this, water is causing the siding to deteriorate. Recommend a qualified roofer or contractor evaluate and correct

Contact a qualified professional.

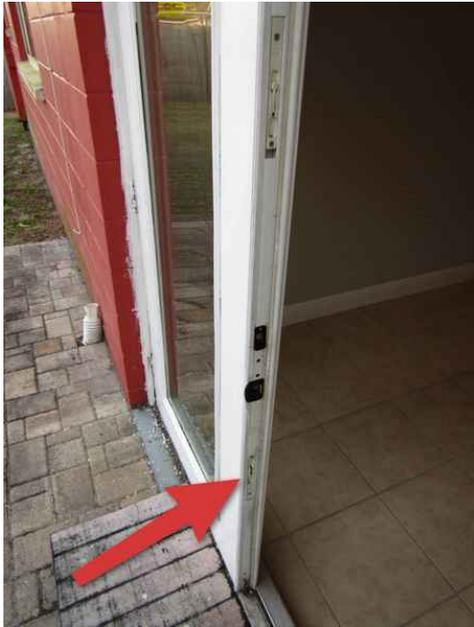
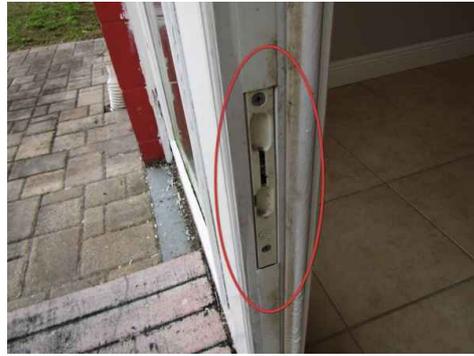
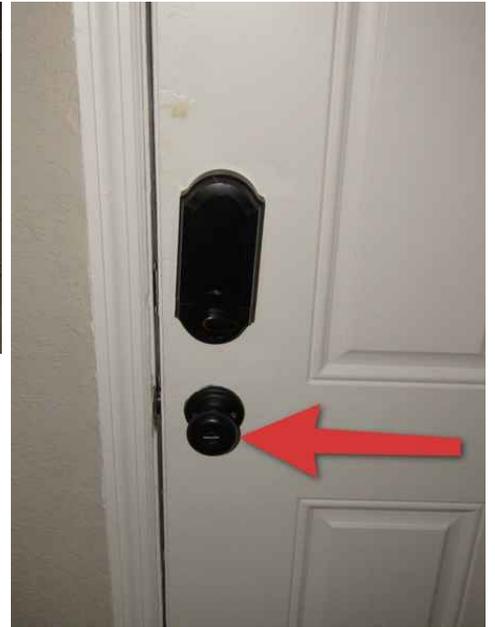
3.2.1 Exterior Doors

**HARDWARE DAMAGED**

The lock on the back door is broken. Recommend repair or replace. On the front door, at times, the doorknob kept slipping when turning it. The pieces inside felt stripped and did not allow the doorknob to function properly.

back door

broken door lock

front door

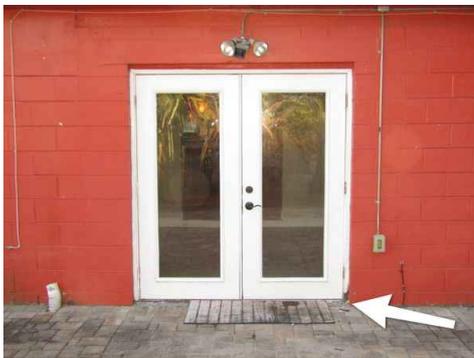
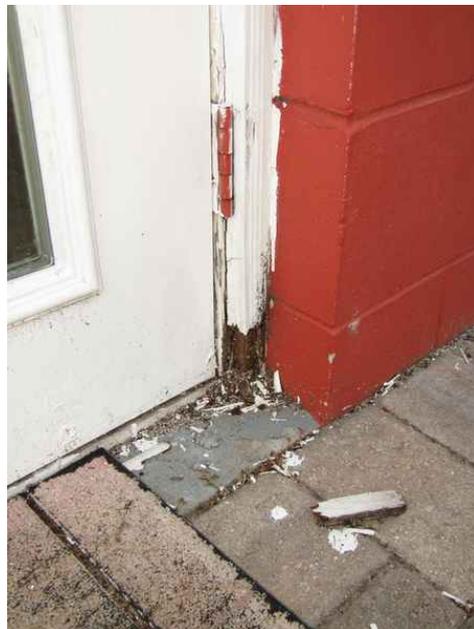
3.2.2 Exterior Doors

**DOOR/DOOR JAM DECAY**

The door jam in the back of the house is experiencing some wood decay. Recommend repairing the rotted spots to prevent any further water damage

Contact a qualified professional.

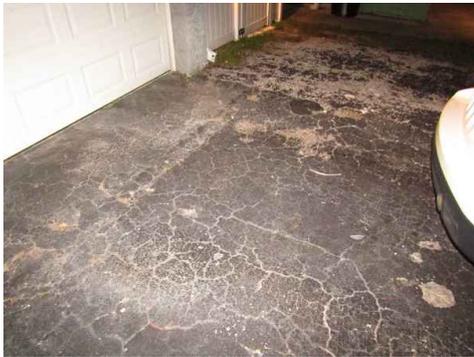
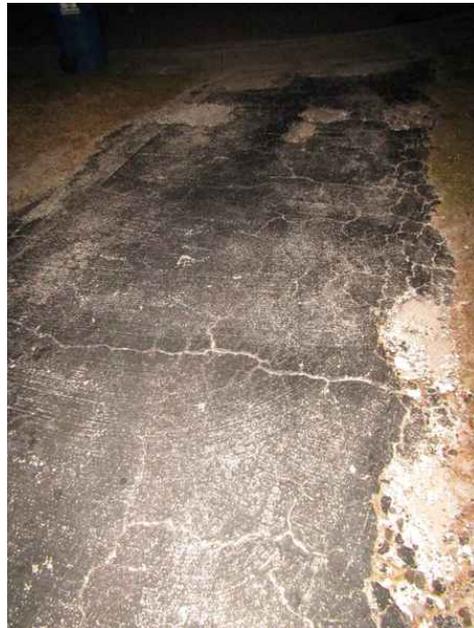
3.3.1 Walkways, Patios & Driveways

**DRIVEWAY CRACKING - MAJOR**

Major cracks and missing chunks of asphalt were observed. Recommend asphalt specialist evaluate and replace.

The condition is also creating multiple trip hazards

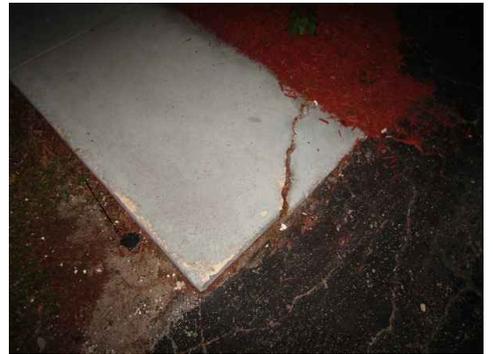
3.3.3 Walkways, Patios & Driveways

**WALKWAY CRACKING - MAJOR**

Major cracks observed. Recommend concrete contractor evaluate and correct to prevent trip hazard & preserve appearance.

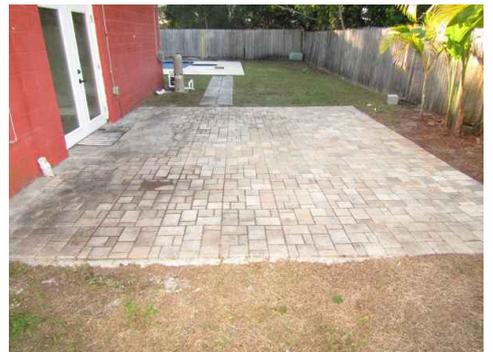
3.3.4 Walkways, Patios & Driveways

**PATIO PAVERS**

There appears to be a drainage concern on the rear patio. We noticed there is wood damage at the base of the back door which is telling us water is likely gathering there not draining properly. Recommend adjusting the patio blocks to allow for proper drainage

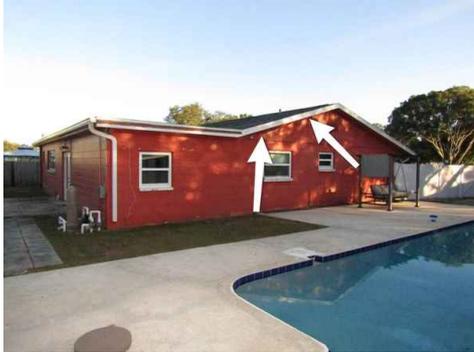
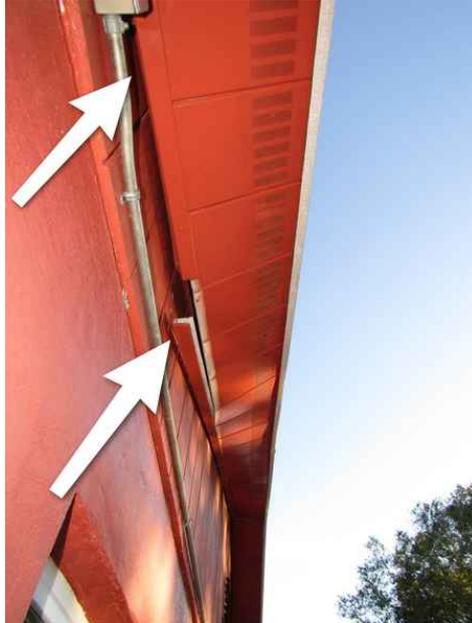
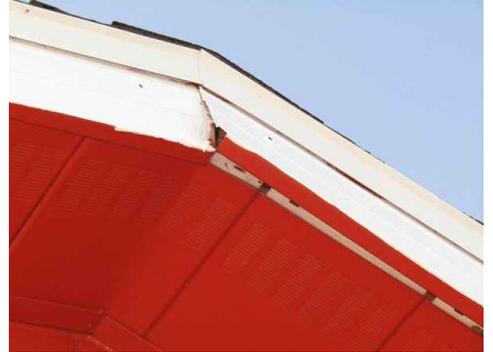
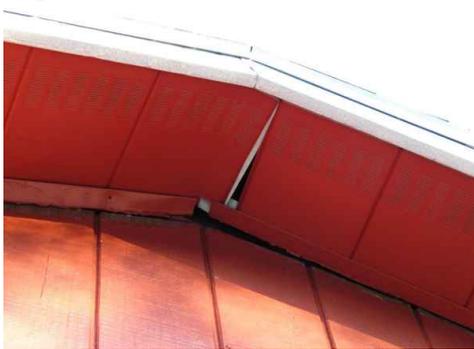
3.4.1 Eaves, Soffits & Fascia

**SOFFITS AND FASCIA CONDITION**

There is more than one area of the soffit and fascia that are in need of repair. All gaps/openings in the soffits and fascia should be sealed to prevent water and pest intrusion.

Contact a qualified professional.

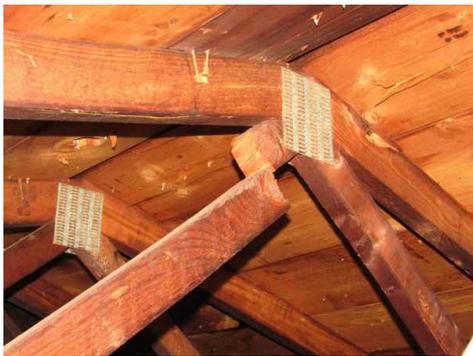
### EVIDENCE OF STRUCTURAL DAMAGE

Evidence of structural damage was found in the ceiling structure. Recommend a structural engineer evaluate and advise on how to repair.

above garage

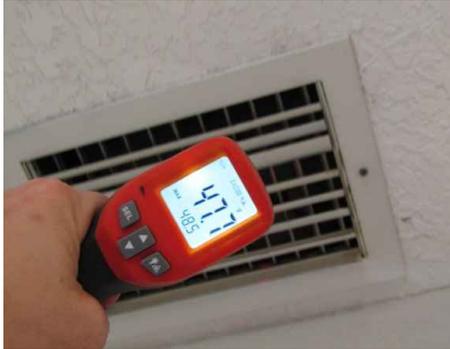
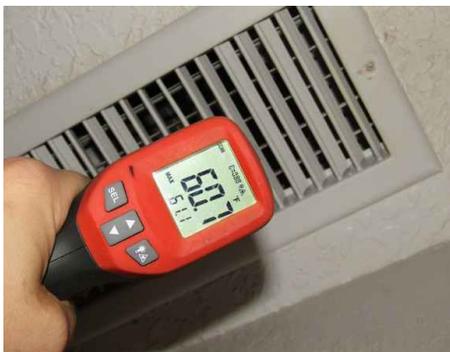
The desired temperature differential between the Air Supply and the Air Return is 16-22 degrees. This would indicate the AC system is working efficiently. For this system, the temperature differential is showing a range of 7-21. It is not as efficient as it could be and needs to be inspected further by an HVAC technician

The temperature of the air coming from the hall bathroom and the two bedrooms next to it was registering 6-15 degrees warmer than the vents in other parts of the house. I recommend a licensed HVAC technician evaluate the system and make the necessary corrections. Ducts in the attic that are not properly insulated will also affect these numbers

air supply

Bedroom

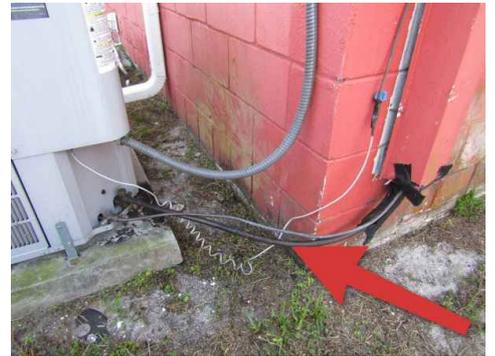
6.1.2 Cooling Equipment

**SUCTION LINE INSULATION**

The suction line on the exterior unit was missing insulation. It is recommended this line be insulated to help the efficiency of the HVAC system

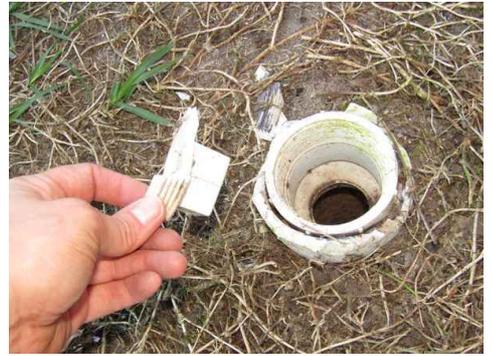
The cover for the cleanout in the back of the property is broken and should be replaced

Contact a qualified professional.

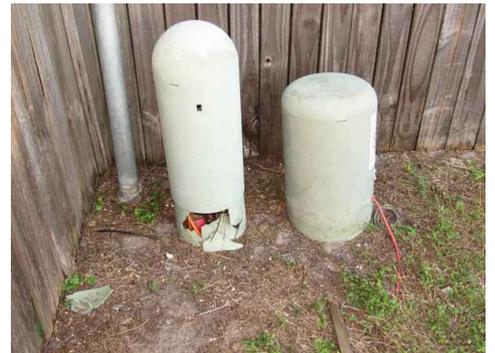
8.1.1 Service Entrance Conductors  
**BOXES DAMAGED**

I recommended the electrical company inspect these containers and replace them with non broken ones

Contact a qualified professional.

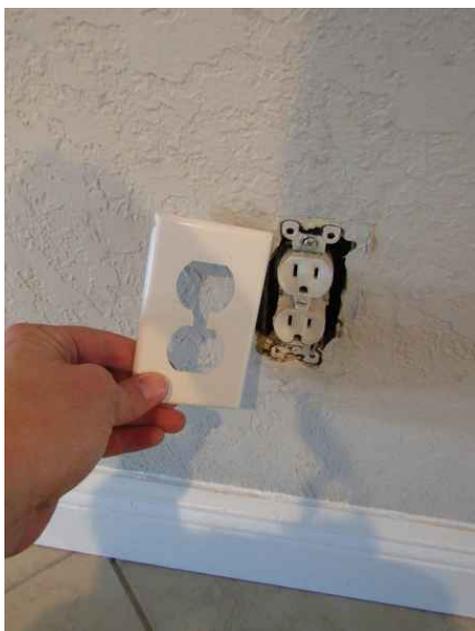
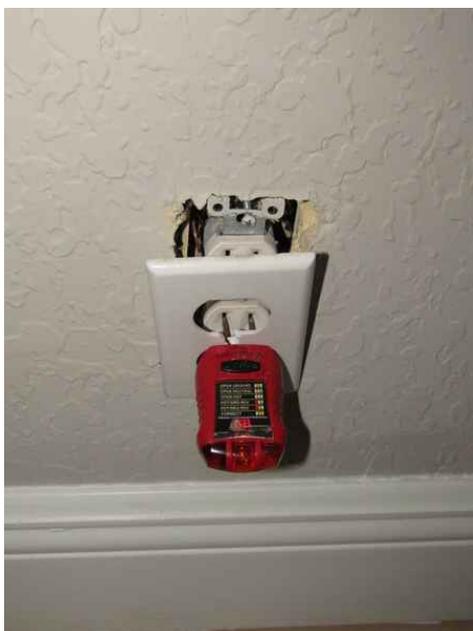
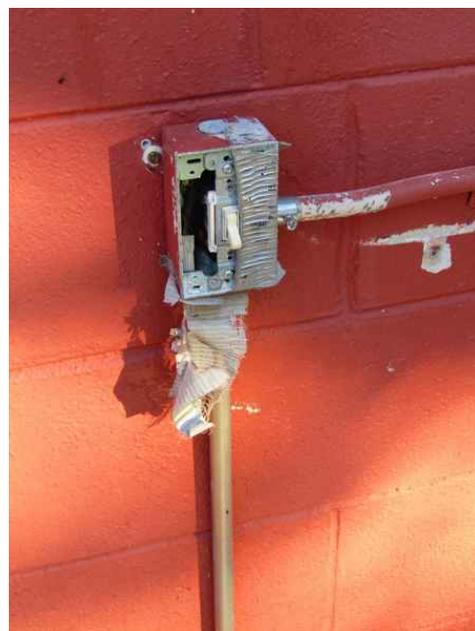
8.4.1 Lighting Fixtures, Switches & Receptacles

**COVER PLATES DAMAGED**

There are multiple outlet covers that are cracked/broken/not secured. Recommend replacing all broken outlet covers to eliminate the chance of a safety hazards

pool light

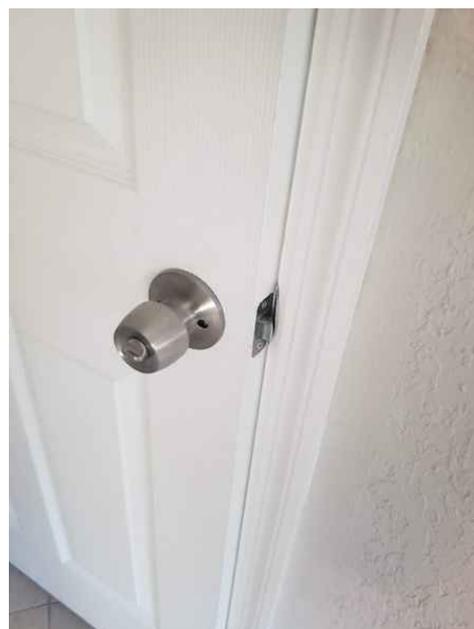
**DOOR DOESN'T LATCH**

The door doesn't latch properly for the bedroom to the right of the bathroom. Recommend handyman repair latch and/or strike plate.

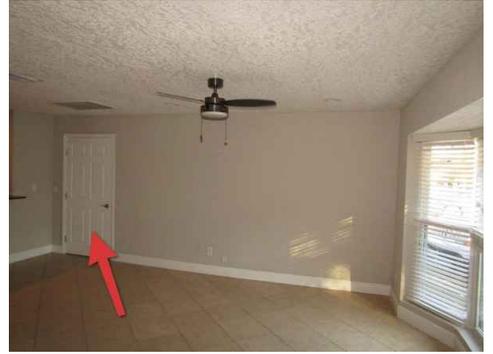
10.1.2 Doors

The door leading from the main living area into the garage should be a self-closing fire-rated door. This door was missing its sticker that tells the fire rating so i can not confirm

Contact a qualified professional.

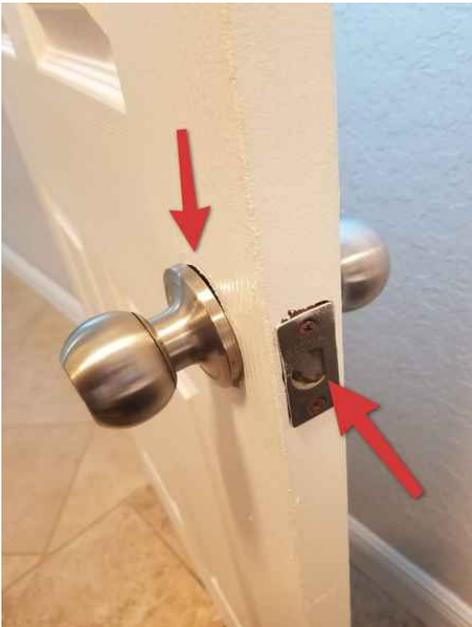
Master Bathroom

The hardware for the master bathroom door is damaged and not functioning properly. The doorknob is also very loose. Recommend a handyman repair the hardware to operate properly. The lock is missing/broken on the handle of the door for the master bedroom

Contact a qualified professional.

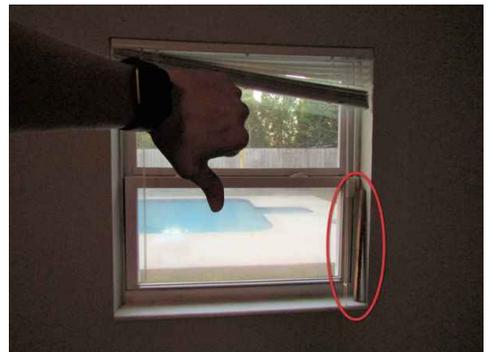
The window in the back bedroom would not open. There was also this piece of wood leaning against it. I am not sure why the window isn't working but for safety reasons, the window should be fixed to open and close smoothly. I recommend a contractor or window specialist evaluate all the windows

Contact a qualified professional.

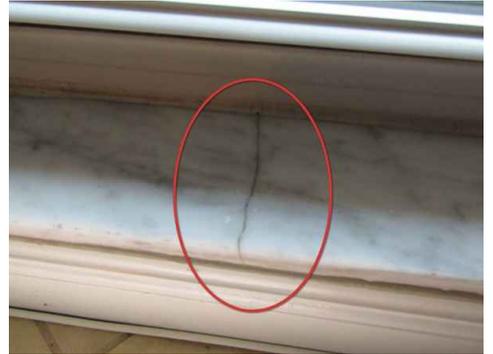
## 10.2.3 Windows

**WINDOW SILLS**

One of the window sills in the bedroom is cracked

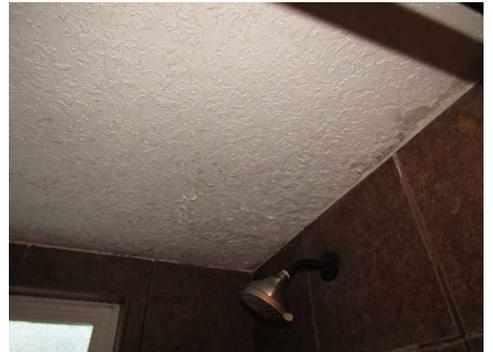
## 10.5.1 Ceilings

**MINOR PATCHING NEEDED**

Bathroom

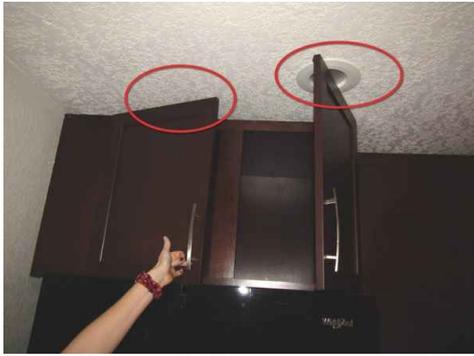
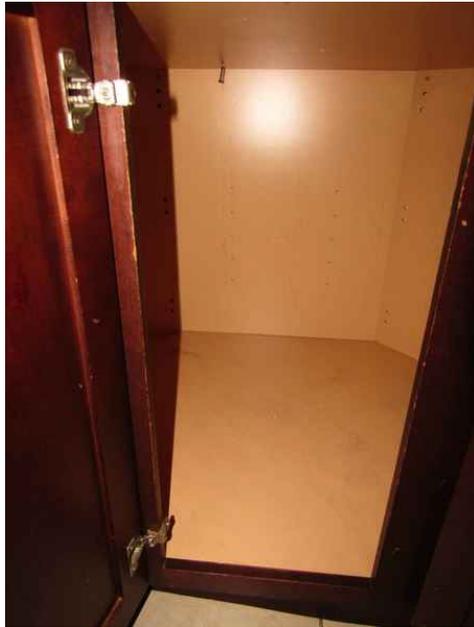
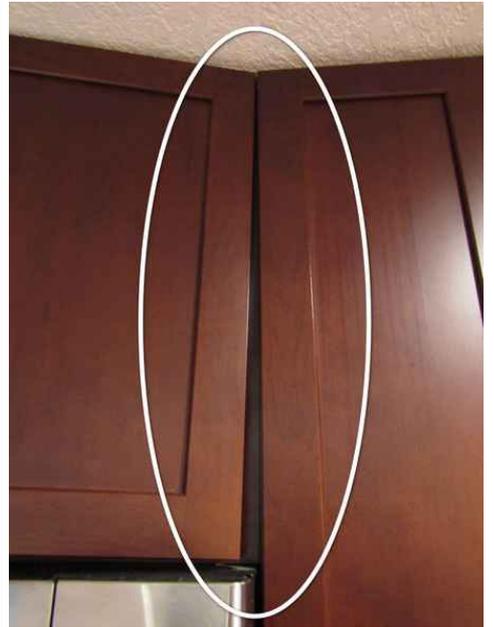
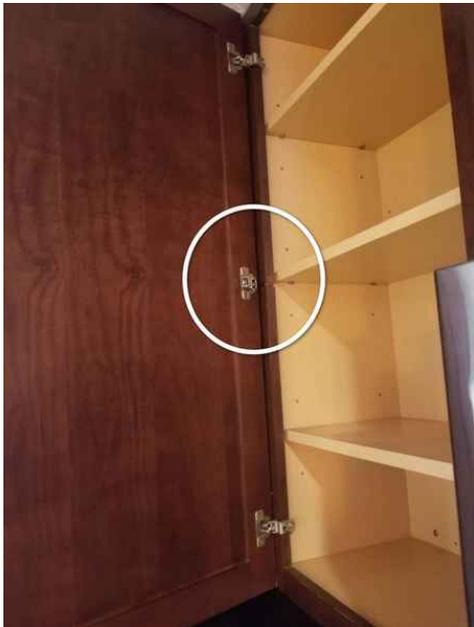
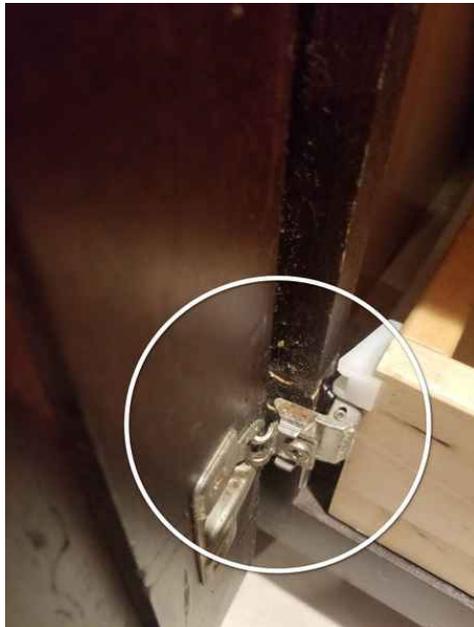
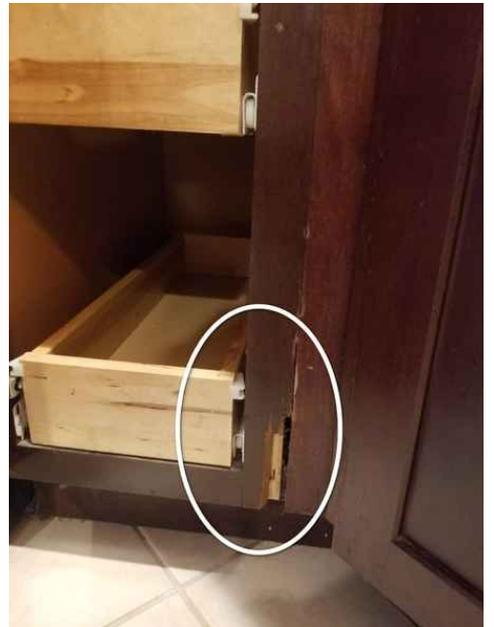
## 10.6.1 Countertops &amp; Cabinets

Multiple kitchen cabinet doors need adjusting. There are loose/damaged hinges that affect the way the doors open and align when closed.

hits ceiling and fridge

no shelves

above microwave

hinge not connected

broken

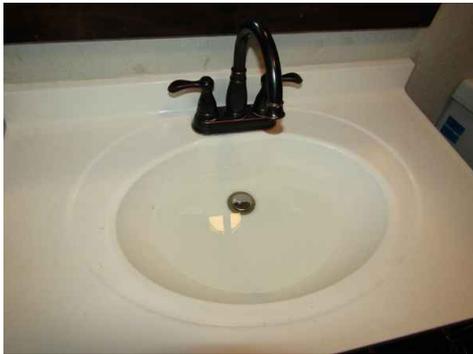
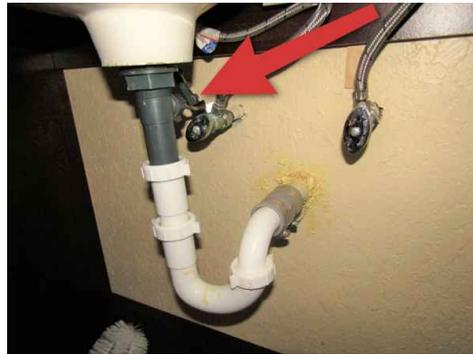
10.7.3 Bathroom Tub/Shower

**SINK STOPPER**

The sink stopper in the master bathroom is damaged and not allowing the sink to drain properly. Recommend replacing the stopper

the sink stopper is bent from the pipe under the sink

Contact a qualified professional.

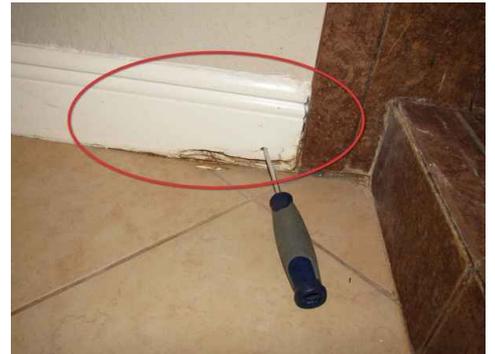
10.7.5 Bathroom Tub/Shower

**WATER DAMAGE**

Evidence of water damage was noticed on the baseboard next to the shower. I recommend making shower the shower curtain in long enough to keep the water inside the shower. Also i would purchase a floor mat to absorb any access water that winds up exiting the shower by mistake. This may be why the previous occupants removed the shower door. It could have been directing the water outside the shower.

Bathroom

I recommend replacing the baseboard to rid the water damage and any mold that grows from the moisture

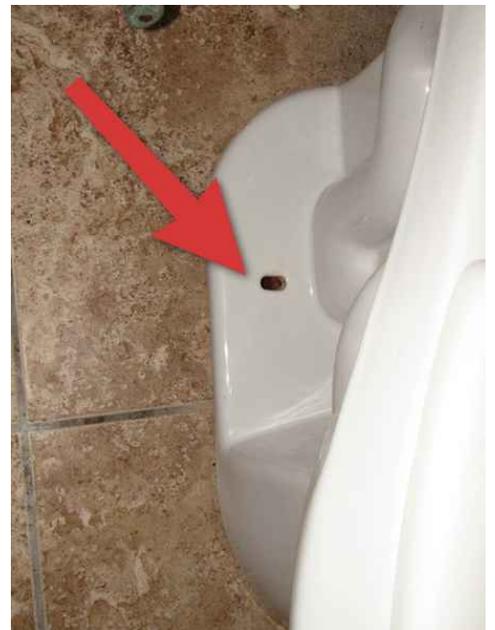
10.7.6 Bathroom Tub/Shower

**TOILET CONDITION**

Both of the toilets are loose and need to be properly secured to the floor. There are suppose to be bolts securing the toilet down but there is one missing in the master bathroom  
The flush button for the toilet in the master bathroom was not operating to the best of its ability. These buttons can be adjusted so i recommend repairing it
